Contract #: 04-0120F4Cty: SF/ALA Rte: 80 PM: 13.2/13.9File #: 1.28**WELDING INSPECTION REPORT****Resident Engineer:** Casey, William**Address:** 333 Burma Road**City:** Oakland, CA 94607**Report No:** WIR-029853**Date Inspected:** 24-Jun-2013**Project Name:** SAS Superstructure**OSM Arrival Time:** 930**Prime Contractor:** American Bridge/Fluor Enterprises, a JV**OSM Departure Time:** 1800**Contractor:** XKT/Nesco**Location:** XKT Engineering, Vallejo**CWI Name:** Wayne Van de Wark**CWI Present:** Yes No**Inspected CWI report:** Yes No N/A**Rod Oven in Use:** Yes No N/A**Electrode to specification:** Yes No N/A**Weld Procedures Followed:** Yes No N/A**Qualified Welders:** Yes No N/A**Verified Joint Fit-up:** Yes No N/A**Approved Drawings:** Yes No N/A**Approved WPS:** Yes No N/A**Delayed / Cancelled:** Yes No N/A**Bridge No:** 34-0006**Component:** Saddle Plate & annealing fixture**Summary of Items Observed:**

WELDING INSPECTION REPORT

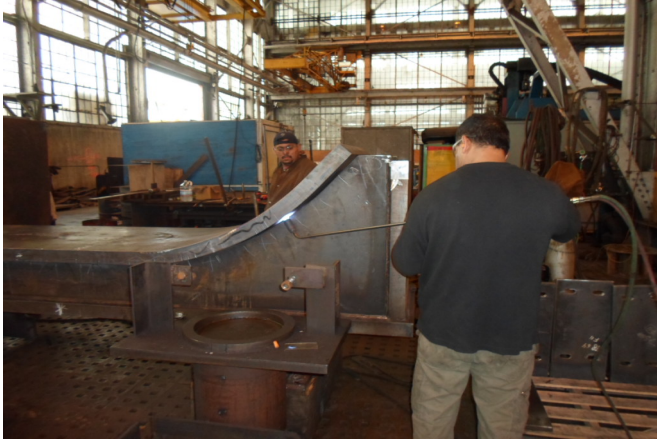
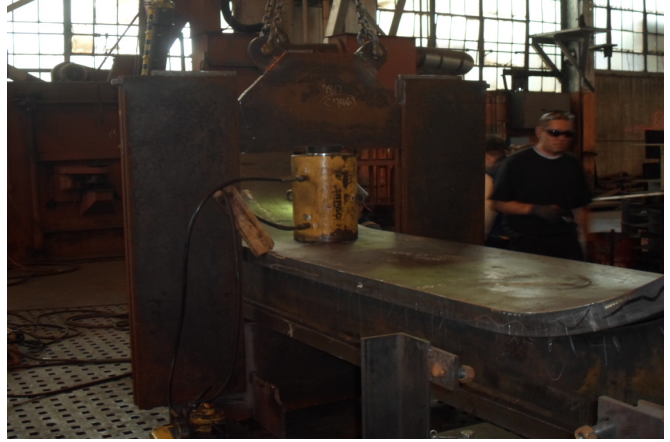
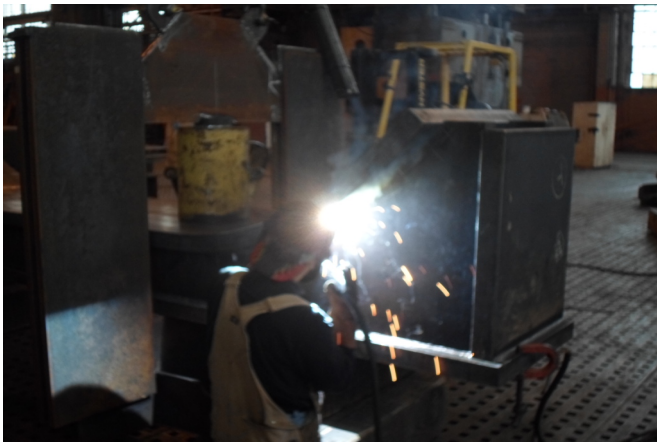
A 3" thick upper saddle plate identified as item S10A-c1 was preheated while in it's annealing fixture prior to being hydraulic-ram frame-pressed into the contours of same fixture. Intermittent fillet welding was performed by the welder Oscar Montana, ID #ZZ, joining the plate to it's annealing fixture utilizing a Lincoln Electric 'UltraCore' 1/16" diameter FCAW-G electrodes as per the Welding Procedure Specification (WPS) identified as XKTD15-00.
